GROUP 3

RAVELIJN OP DEN ZOOM

Introduction

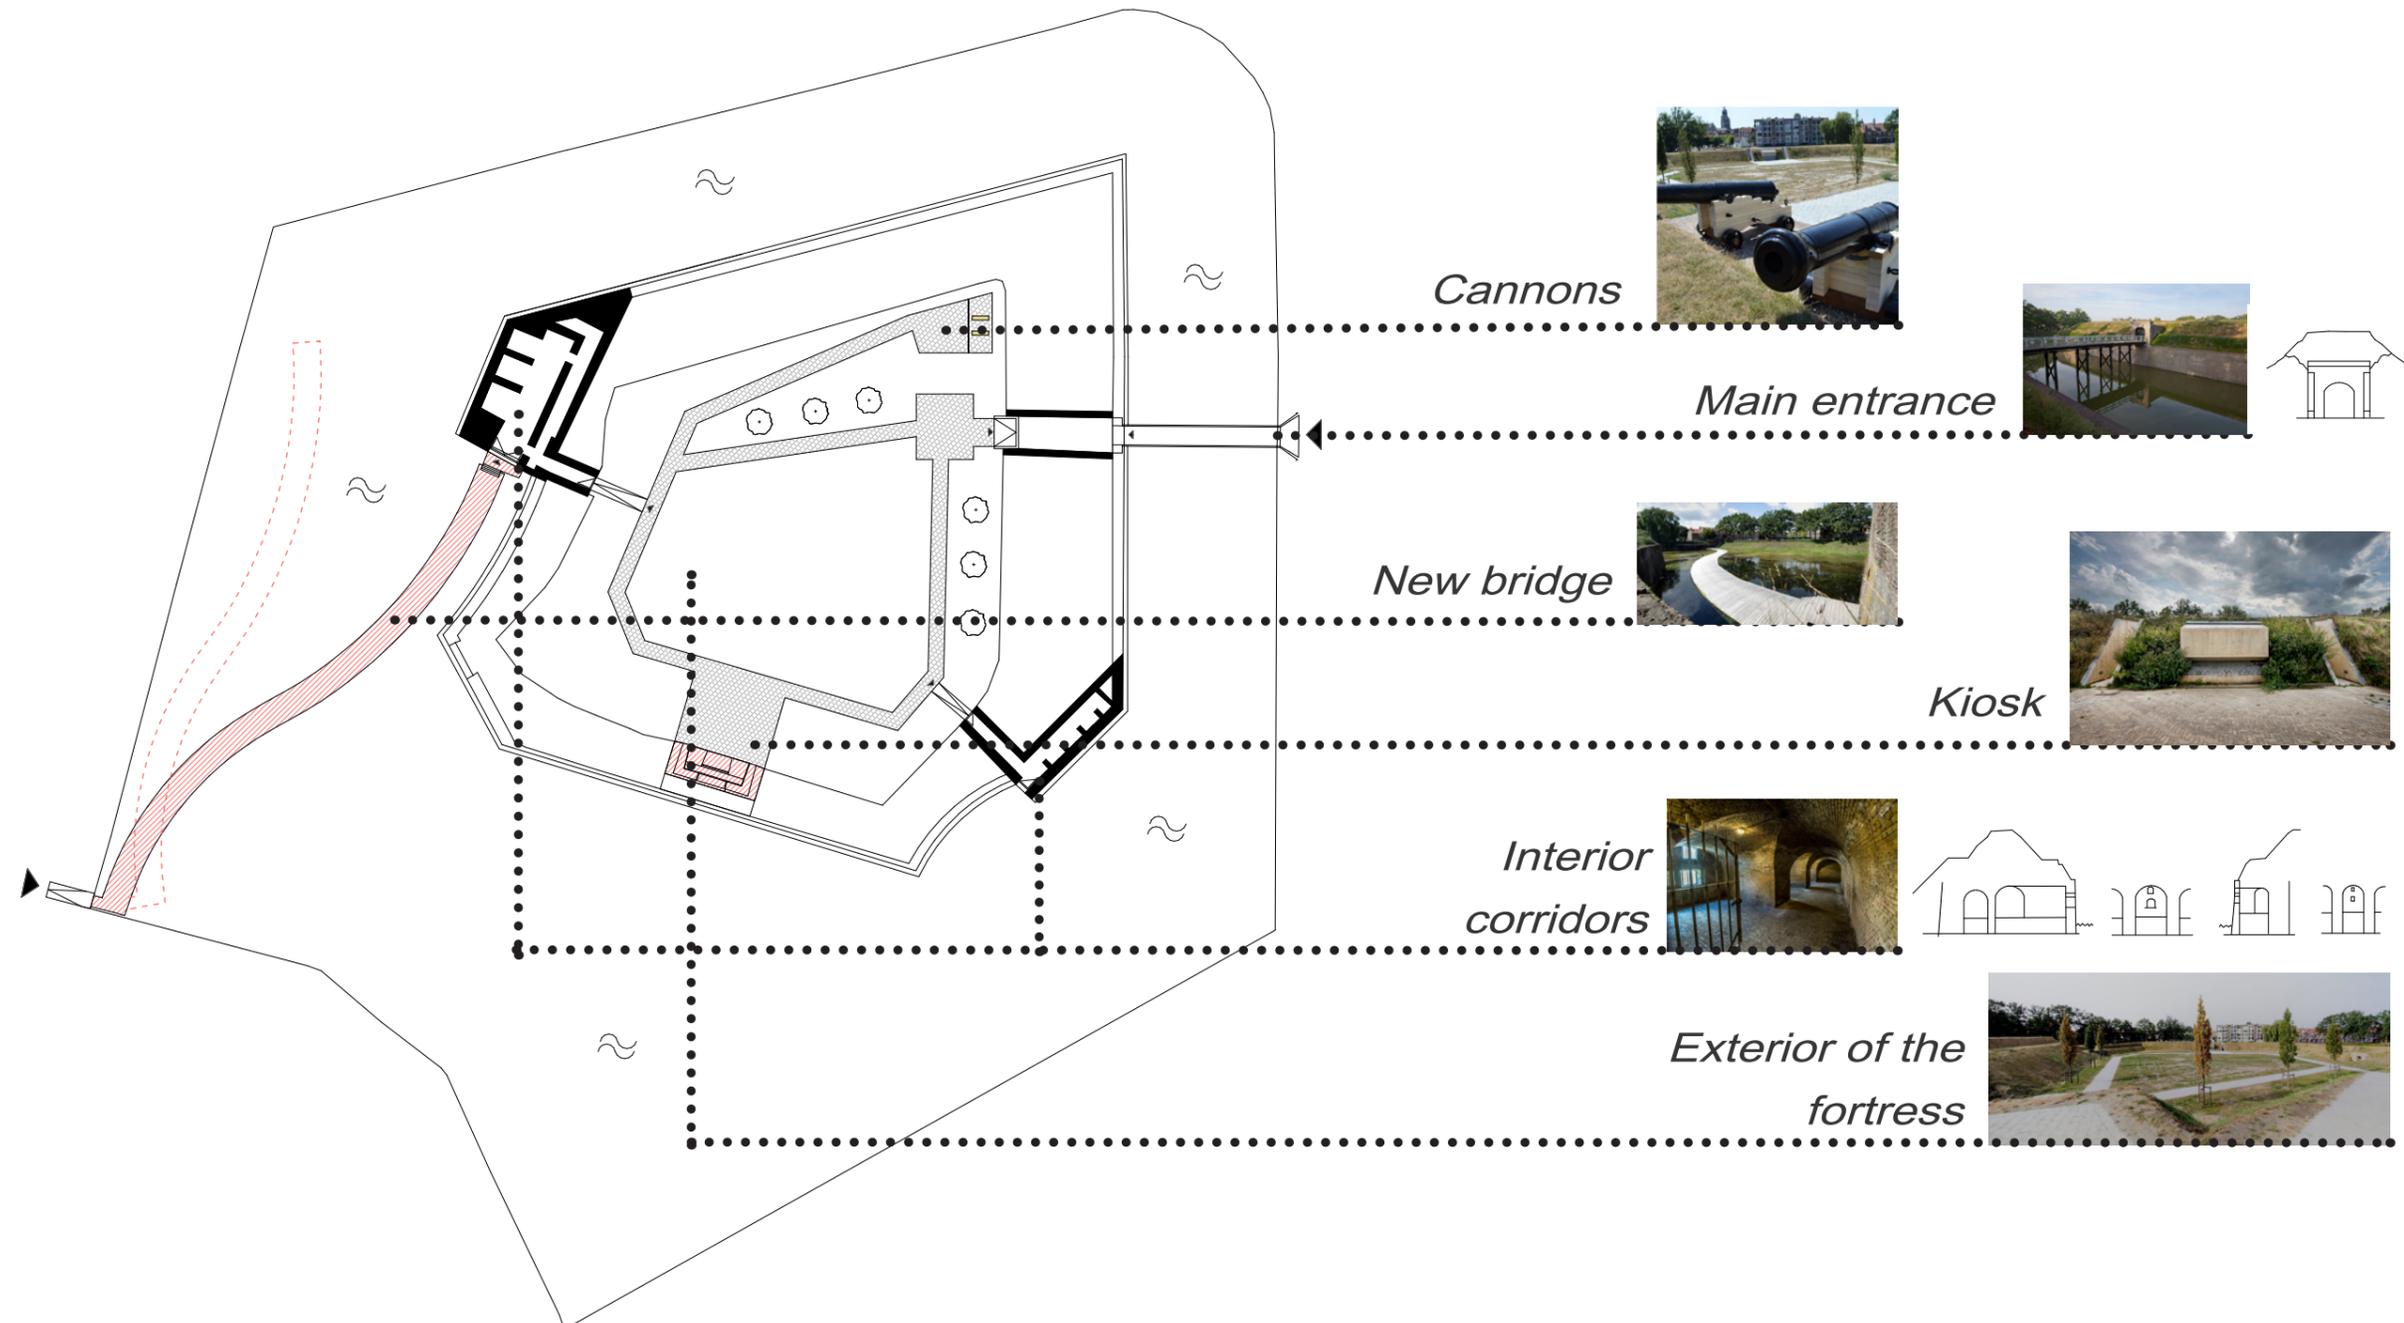
Exterior and interior

The main entrance is from the eastern side across the bridge. The second bridge is from west side from the center. The fortress is completely covered with grass, paved walkways are made for pedestrians. There are currently 6 trees planted on the fort. There are two more entrances to interior corridors from inside the fortress. On the east-north edge of the fortress, there are placed two cannons.

The interior of the fort consists of corridors with barrel vaults made of bricks.

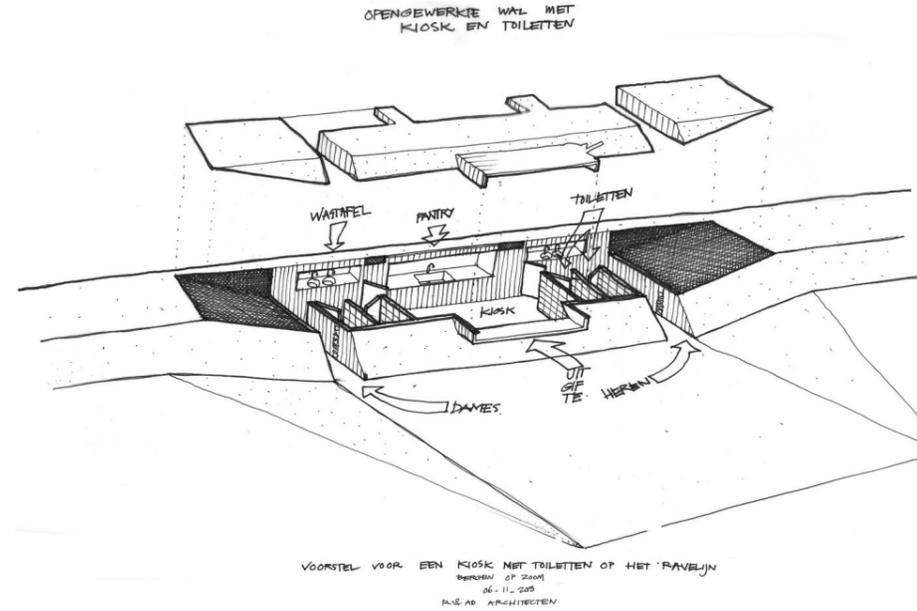
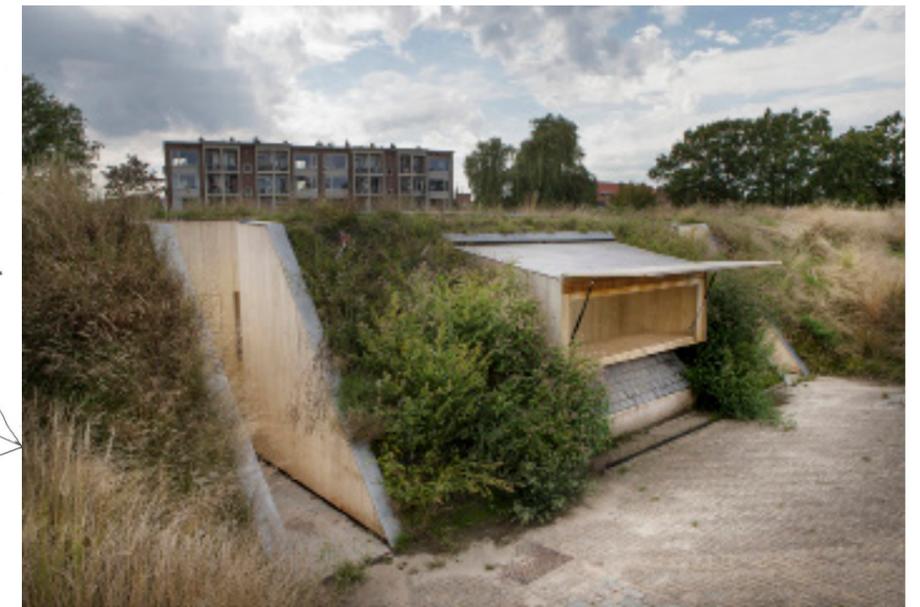
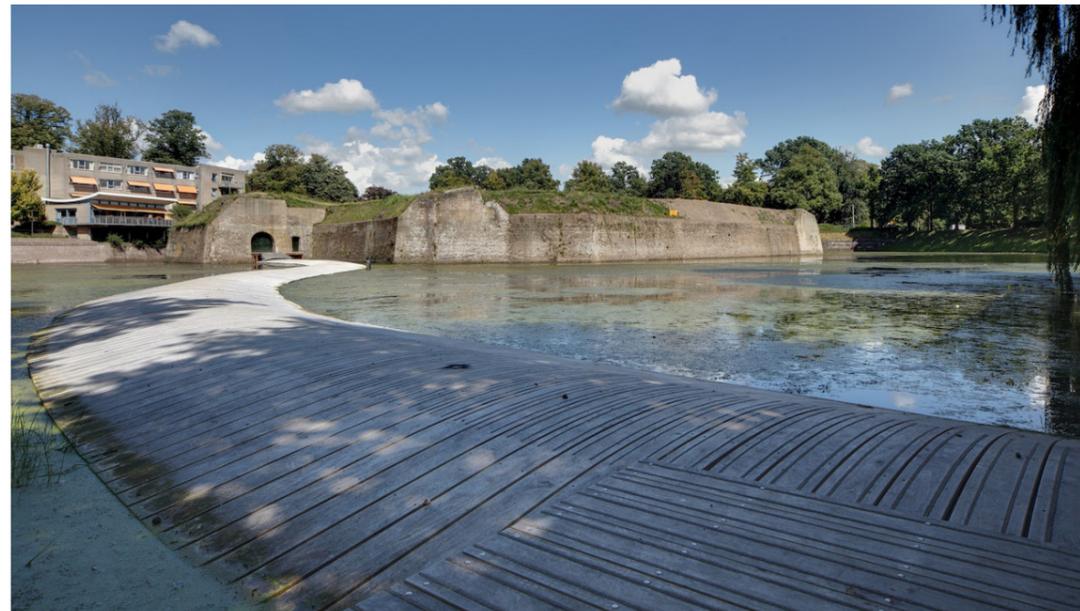
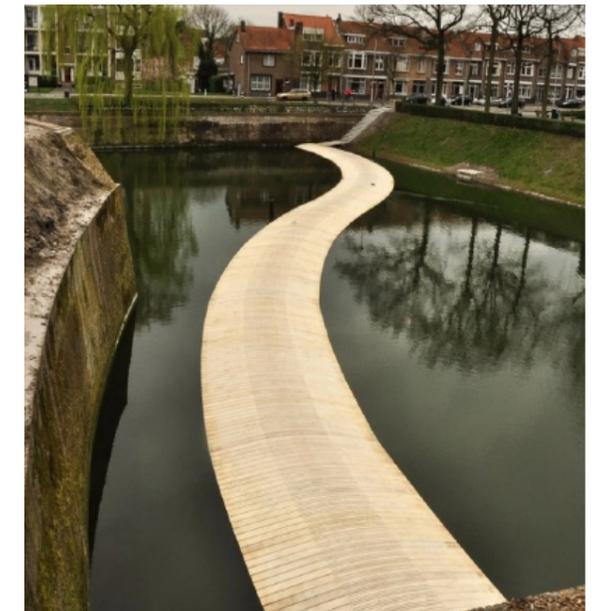
Current use and new transformation

The fort is possible to visit during the opening hours from april to october or on request. It is regularly used for public and private events. In 2015, new kiosk and second bridge were built, both designed by RO&AD Architecten. The kiosk contains public toilets and a coffee/information counter. The kiosk is placed in wall of earth, it has two entrances, one for each toilet and at the front, there is big hatch to open the kiosks bar. The new pedestrian bridge was made for two reasons - to connect the fortress to the city centre, and to make a second escape route from the fortress in case of emergencies. The bridge is floating and in winter it can be pulled to the side, so there can be ice-skated around the fortress.

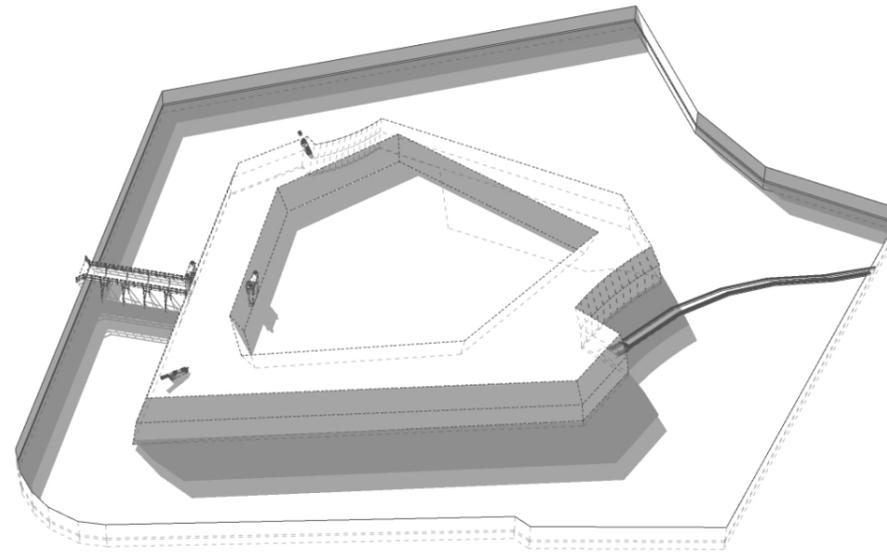
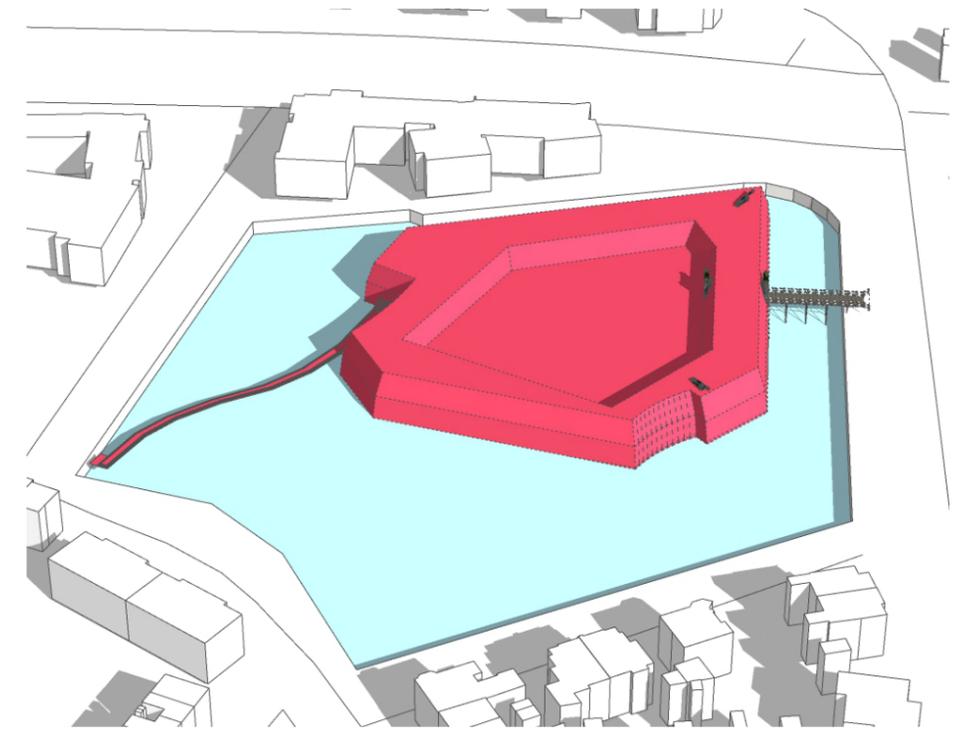
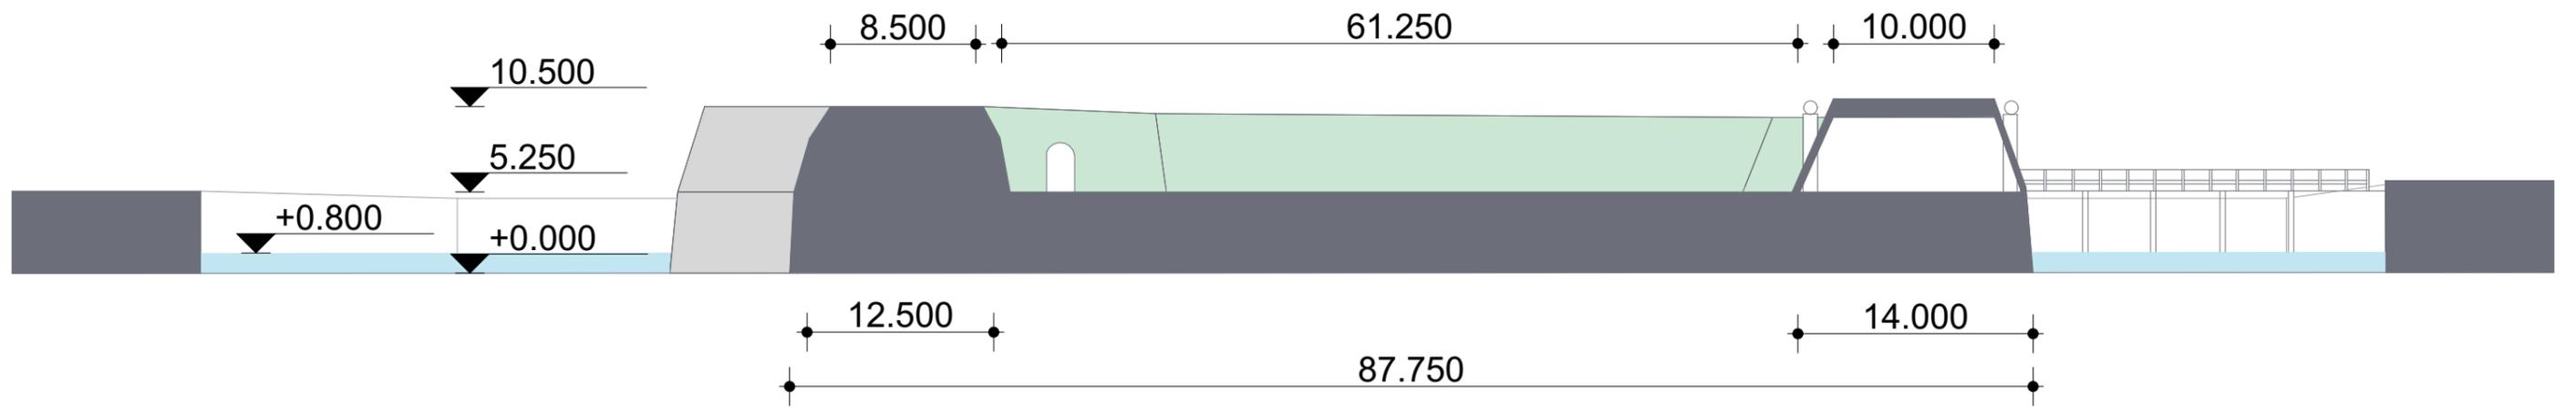
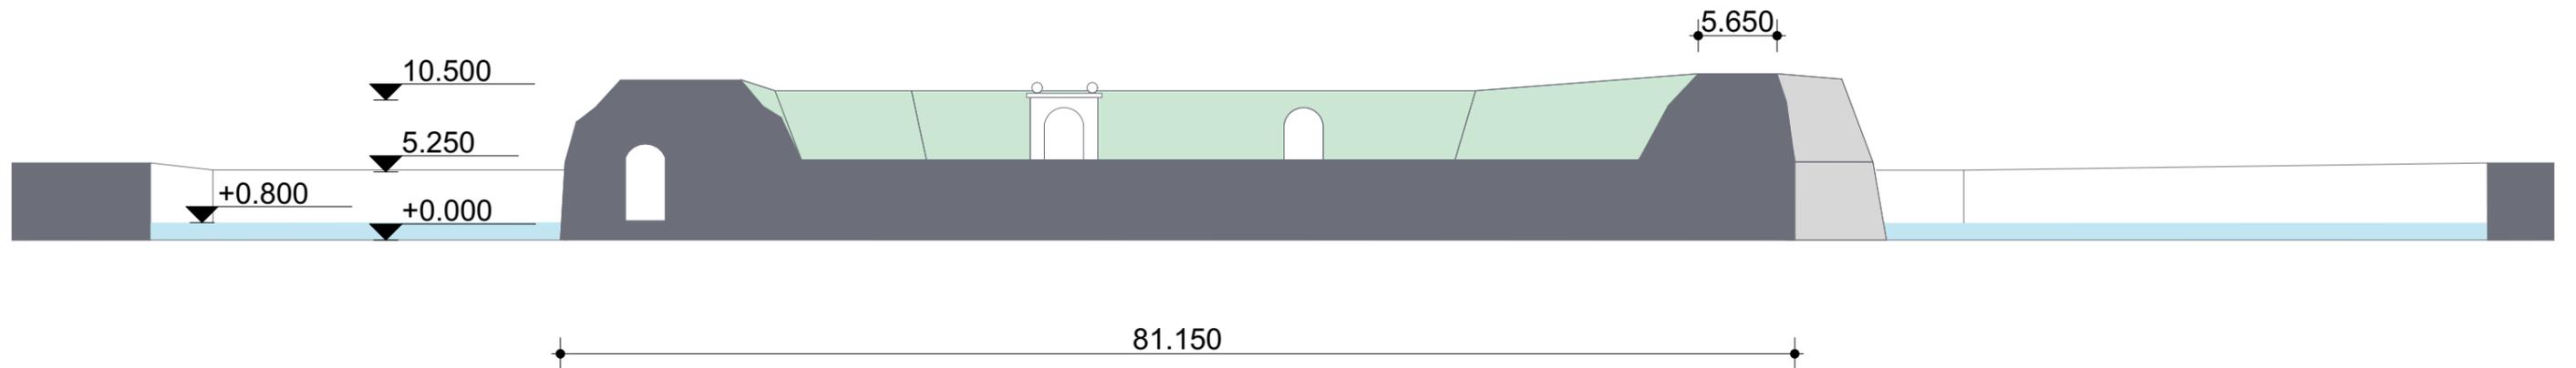
Data Analysis

Ravelijn consists of an island in the middle of a wide moat, which is itself entirely surrounded by earthen ramparts and partly by stone walls. The fort is made of a brick foundation with earth walls on top. The earth walls and mounds are part of the fort on all sides. Except the wall at the side of the city are all original. In times of war this one was not necessary, because there was no attack expected from that side. Fort contains observation and firing slots, weapon cellars and magazines.

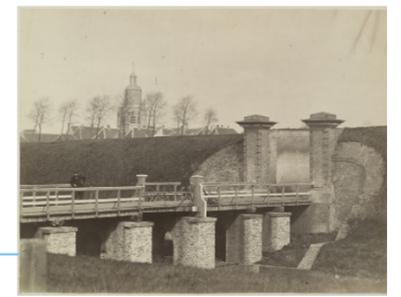
Image 4. First bridge and new entrance gate, 1932

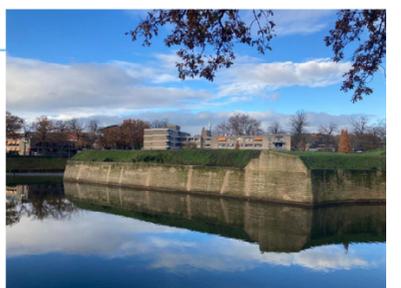
Image 7. Fortress after renovation of the brick wall damaged by trees

Entire pieces of fortress wall have been cut away to remove the roots. It had to be added 150,000 new bricks in the walls. Added features are a kiosk and a new bridge that is a second emergency exit so social events can be held at the fort.

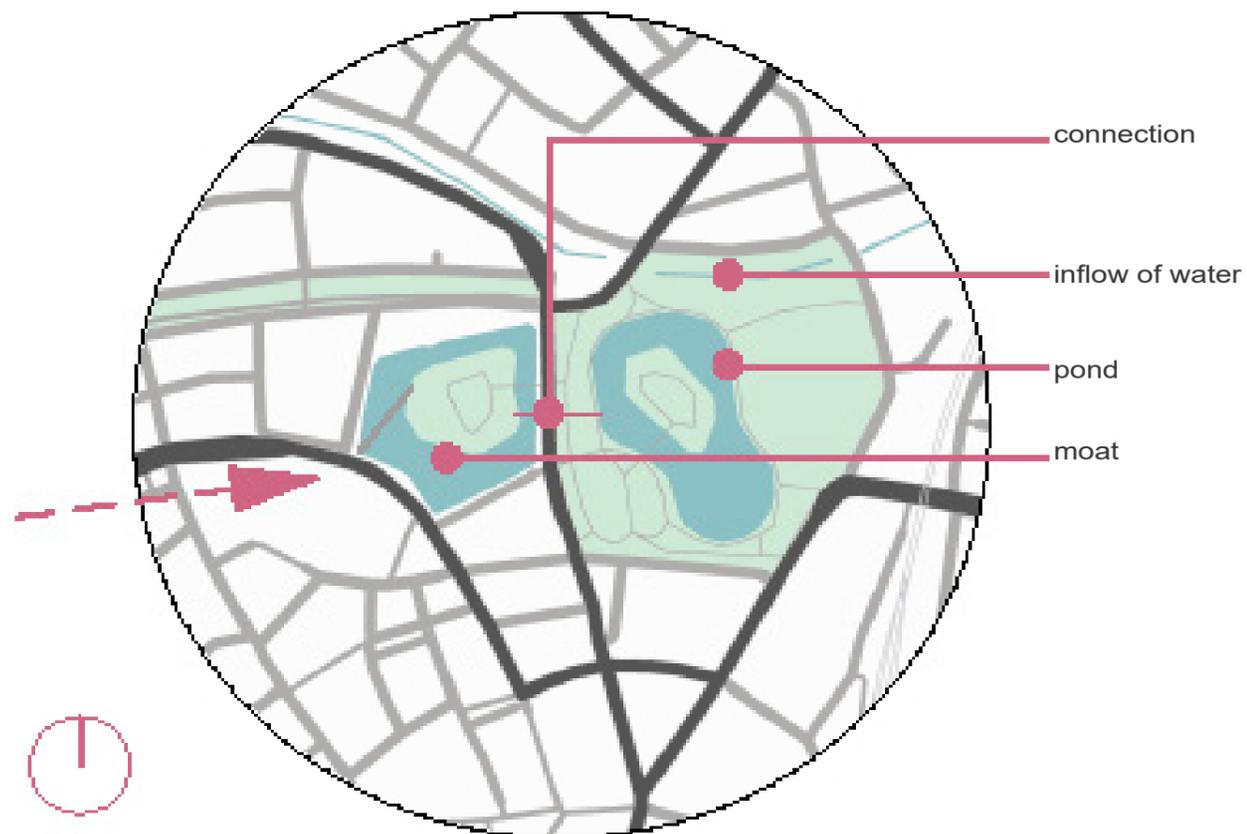
Environmental impacts

The city fortifications of Bergen op Zoom were part of the defense mechanism of the Zuiderwaterlinie. The fort is surrounded by a wide moat. This ditch was and is flooded with water. Thanks to its connection with the water inflow from the south of the city, it was possible to retain the water and use it as needed. Today, this possibility is not used and the water is stabilized at a depth of 80 cm.
